Monitoring Data Record

Project Title: R-3415 NC 67 Widening COE Action ID: 200520314
Stream Name: UT North Deep Creek (Site 6) DWQ Number: 05-0061
City, County and other Location Information: NC 67 2.0 miles west of Boonville and just east of Bryant Road (Sta. 209+25 -L- RT.); Yadkin county
Date Construction Completed: Streambank repairs completed in June 2010 and final planting completed in January 2011 Monitoring Year: (1) of 3
Ecoregion: _____ 8 digit HUC unit 03040101
USGS Quad Name and Coordinates: N 36 14' 11" W 80 44' 34"

UT North Deep Creek (Site 6)

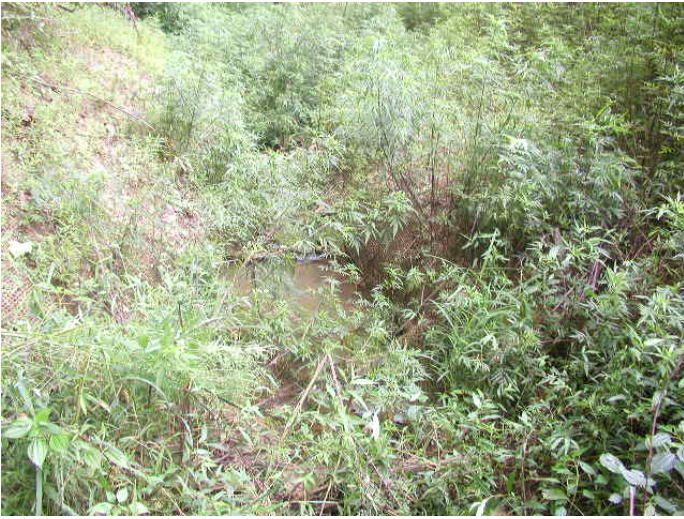
Photo Point #1 (Upstream)

UT North Deep Creek (Site 6) is stable for the Year 1 monitoring evaluation. NCDOT will continue to monitor this stream relocation.

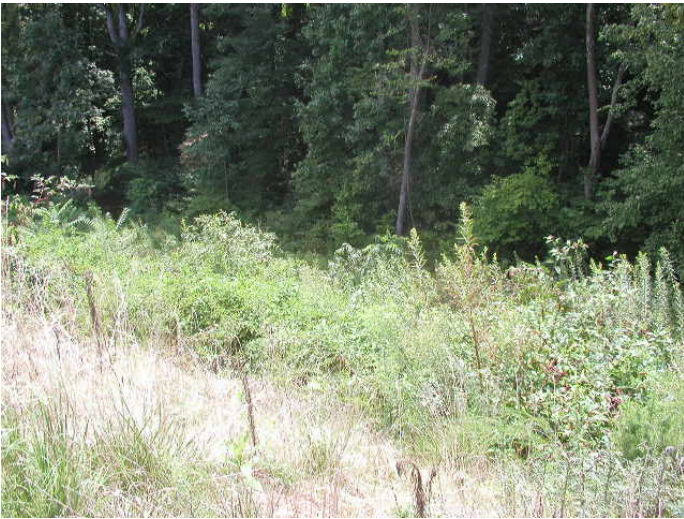
Overview photo of the site

ADDITIONAL COMMENTS: Planted vegetation noted onsite included black willow, silky dogwood, tulip poplar, sycamore, river birch, and green ash. Other vegetation noted included briars, lespedeza, fennel, and various grasses.
